ANTIQUITIES OF THE MESA VERDE NATIONAL PARK

CLIFF PALACE

JESSE WALTER FEWKES

WASHINGTON
GOVERNMENT PRINTING OFFICE
1911

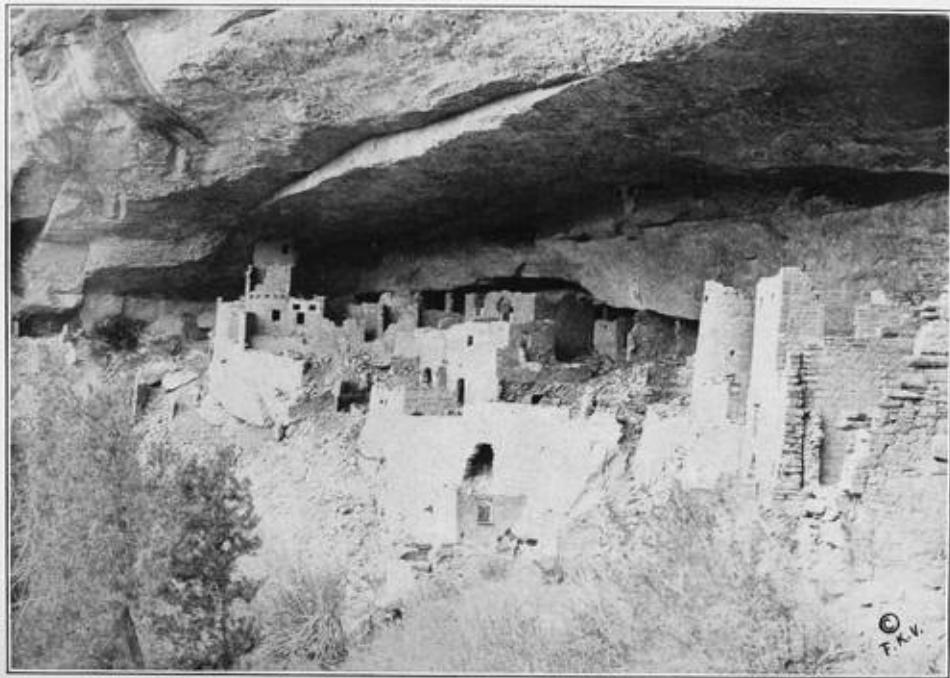
THE SOUTHERN END, AFTER AND BEFORE REPAIRING

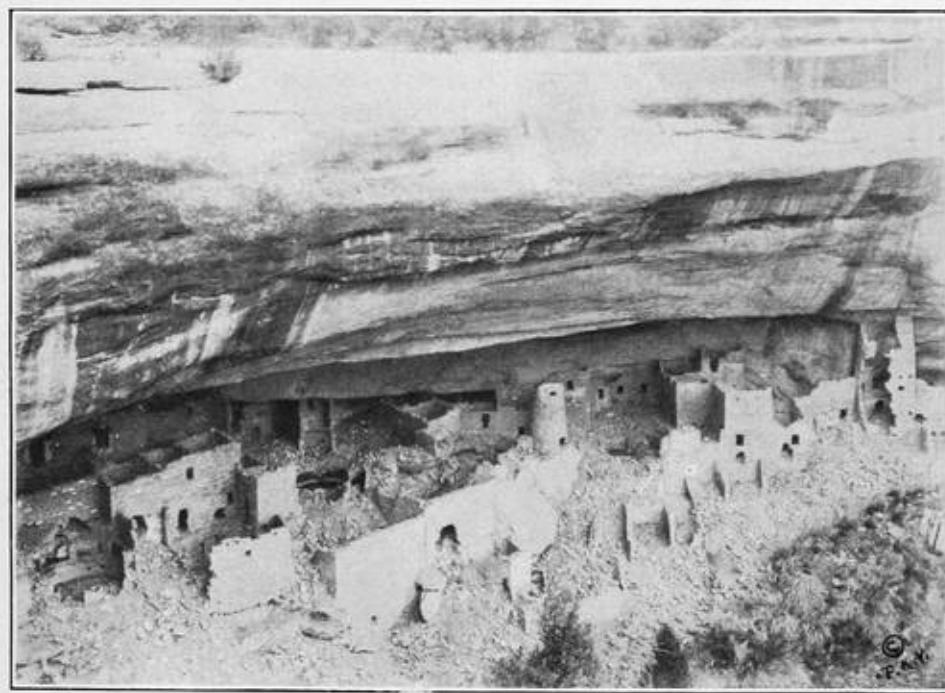
CENTRAL PART, BEFORE REPAIRING

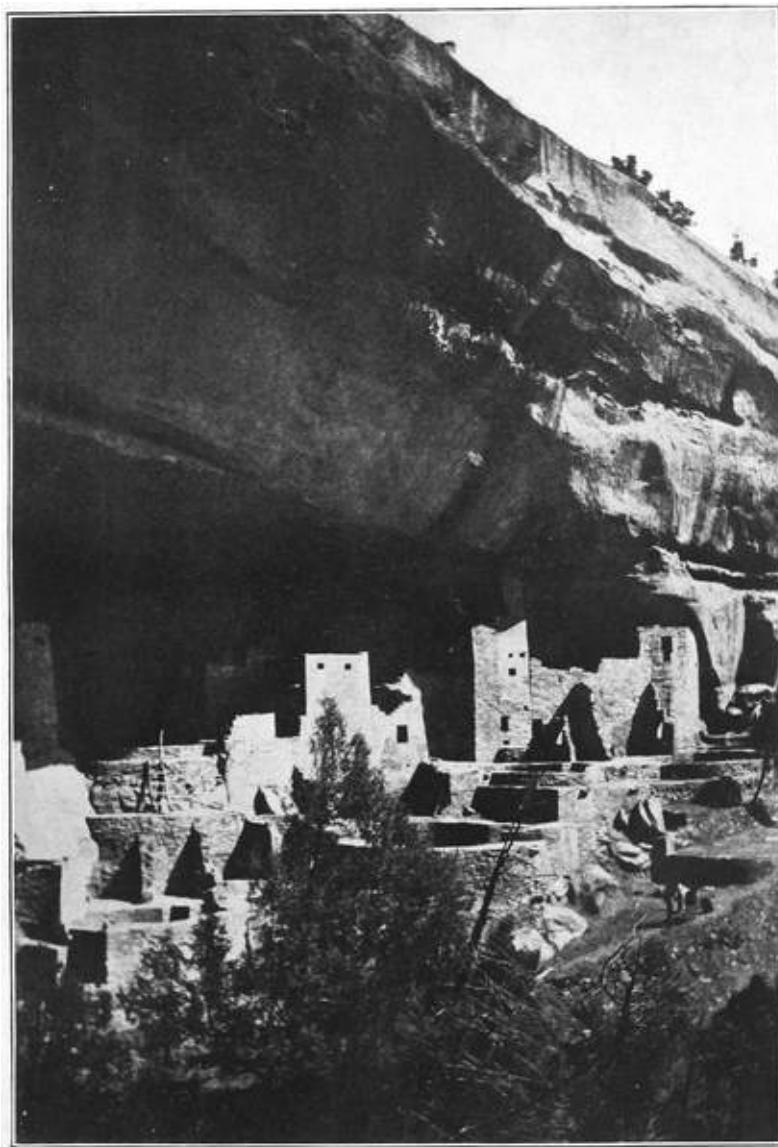
CENTRAL PART, AFTER REPAIRING

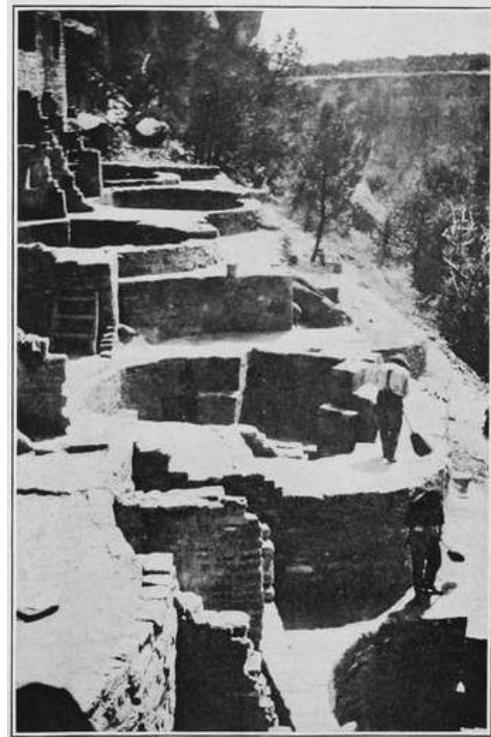
TOWER QUARTER, AFTER REPAIRING
